**Ashington Site 5 and Site 6, West Sussex:
Heritage Assessment**

Project No. 190240

Report No. 2019114

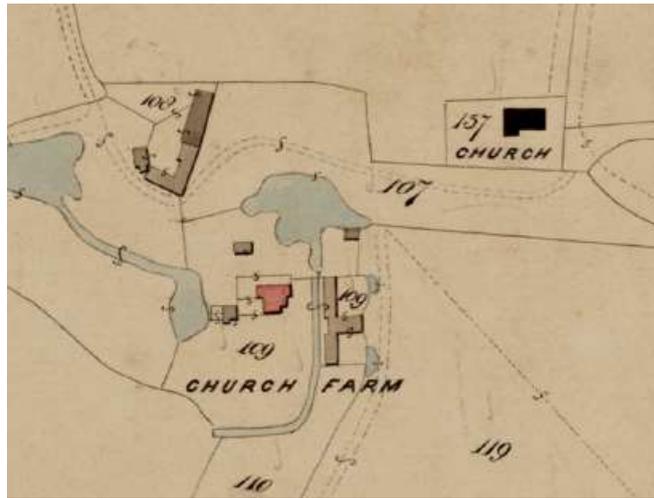
- 2.3 The proposed joint access to the Site formed part of the original access corridor to Church Farm, as shown in the Tithe map of 1847 (plot 107, Church Green and Pond, owned by Sir Charles Burrell and leased by Walter Peachey), with a track that ran south of the church and curved around a large irregular pond, before presumably accessing the house from the north-west (although this is not explicit on the map). The house is shown in red within the former moated site, with a large T-shaped arrangement of farm buildings to the east, with another trackway where the public footpath now runs. This remained the case until recently, as the Ordnance Survey map of 1974 shows, indicating that the existing gravel drive is very recent in date:

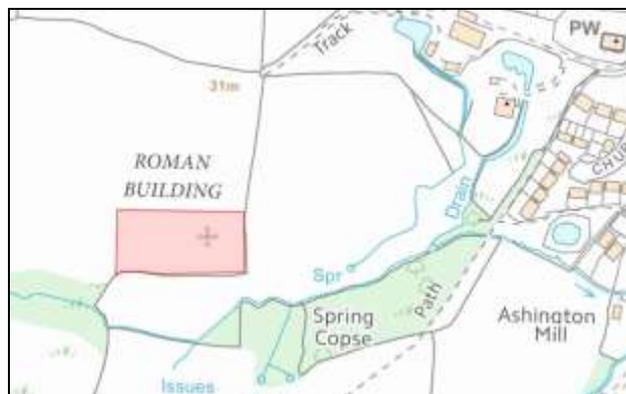
Image derived from NHLE

- 4.2 The scheduled monument is located immediately west of Site 5, separated by the hedgerow (see map extract below). The results of geophysical survey suggest that associated archaeological deposits extend into Site 5, although this has not been confirmed by excavation.

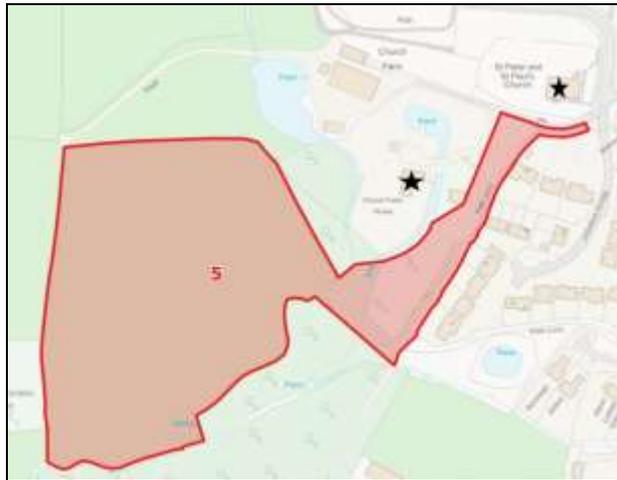
- 4.3 Two listed buildings are located within close proximity to the proposed access route (marked by stars on the map extracts below): the Parish

Church of St Peter and St Paul (Grade II* - NHLE Ref. 1027442) and Church Farmhouse⁴ (Grade II – NHLE Ref. 1353978). The latter also marks the location of the non-designated moated site. These have been assessed for potential impacts on their setting.

Site 5 in relation to the listed buildings

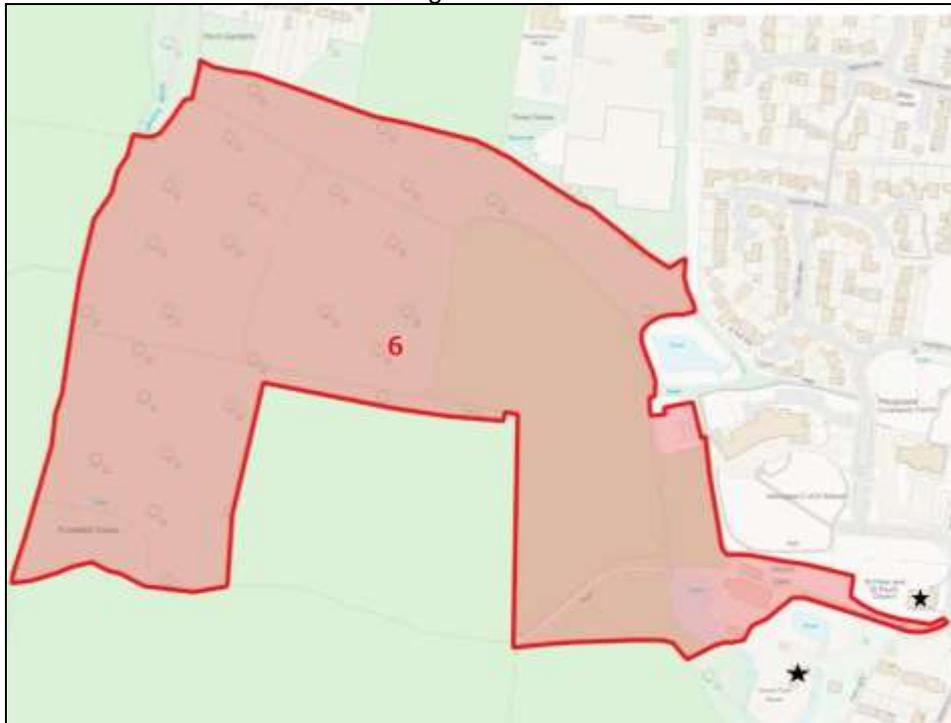
Site 6 in relation to the listed buildings

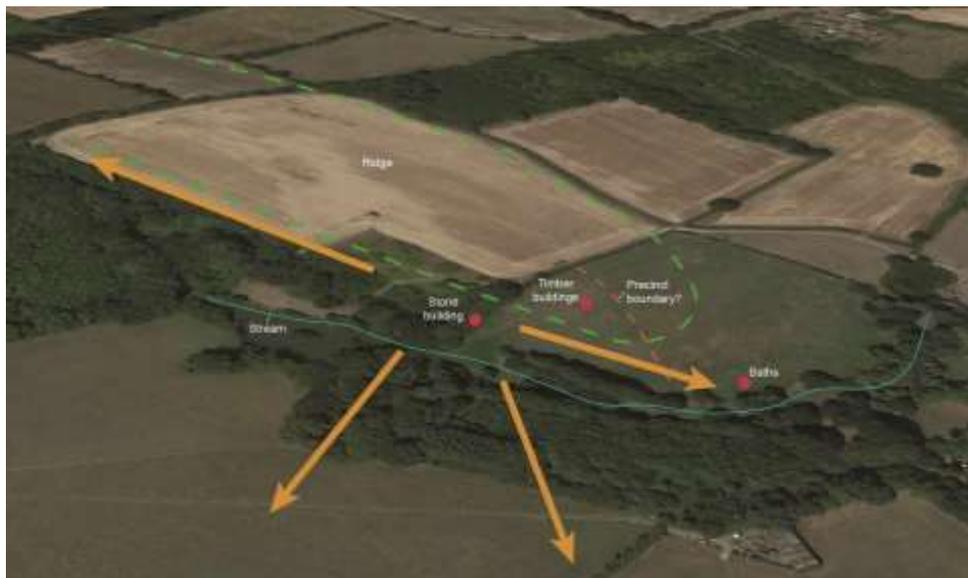
Landscape setting and location of archaeological features in relation to key views (yellow arrows) and stream

- 4.6 The new geophysical evidence suggests that the villa complex extends further east than previously thought. A loose reconstruction of layout is possible (see above), with a stone structure located towards the southern edge of the slope within the SM, extending into the western edge of Site 5 itself (closely constrained by steep rising ground preventing any views northwards) (see 6 on the figure below). Further structures, possibly of timber construction, lie just to the north-east on the southern edge of the ridge-top (9). A further stone structure, interpreted as a bath-house (1), lies at the foot of the slope to the east, within the stream valley. A linear feature running between the bath-house and the northern edge of the possible timber buildings may represent a precinct boundary following the edge of the ridge (though it could also be part of an associated field system or a much later feature) (5 – southern line). Field systems lay to the north.

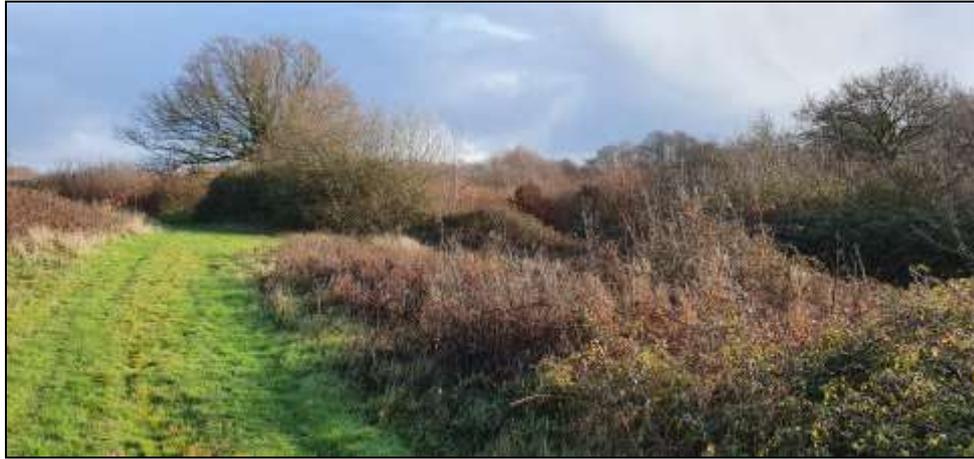
View of interior of the SM, looking E (building identified in 1999 geophysics lies at the base of the slope to the right of the photograph)

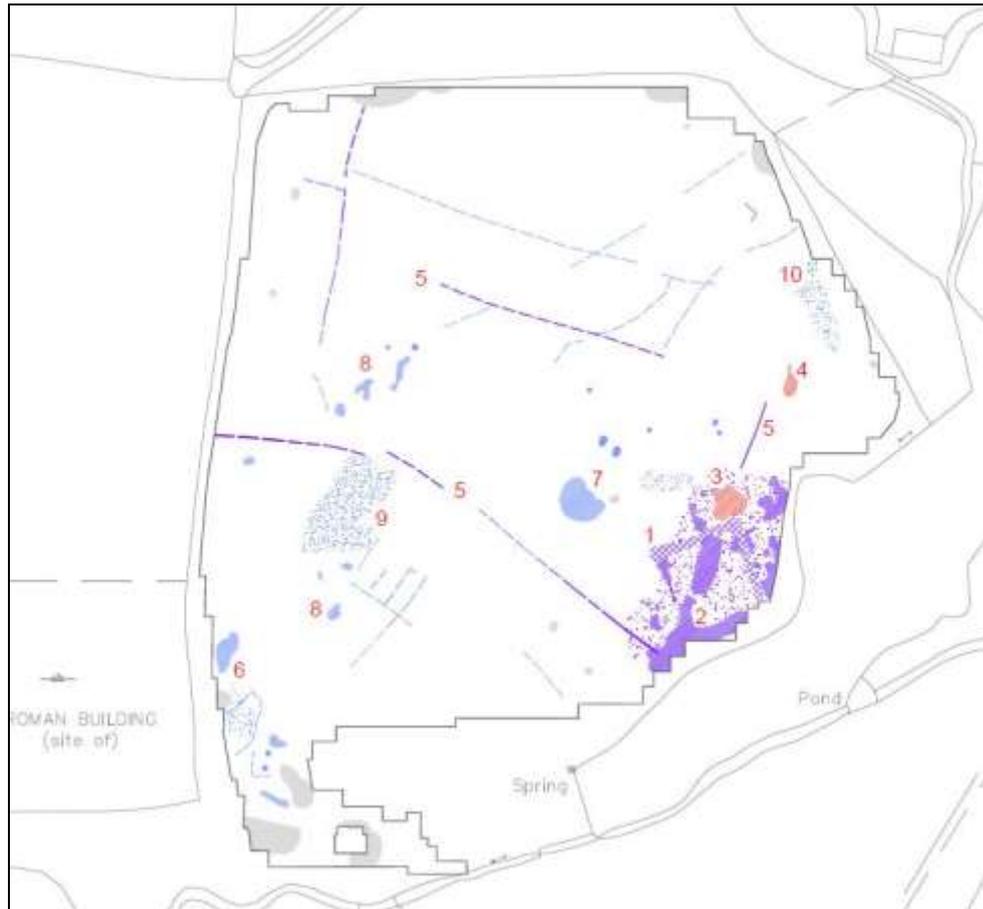
Extract from Fradgley 2019

- 3.4 However, a recent detailed magnetometer survey of the Site 5 field (Fradgley 2019) has provided further evidence, including a rectilinear anomaly in the south-east corner of the site surrounded by strong magnetic anomalies suggestive of fired brick, tile or other burnt deposits, with a strong thermoremanent response immediately north. This is interpreted as a potential bath-house with associated heating furnace. The location next to a spring would be ideal for water supply. An additional smaller kiln-like feature lies further north. The area of possible buildings in the western part of the field, identified in 1999, produced a weak magnetic response suggestive of more ephemeral features such as timber buildings. Both surveys also identified a series of linear features across the northern half of the field interpreted as ditches relating to a field system, although one east-west boundary could conceivably represent the boundary of a precinct boundary (another common feature with villas), with the southern boundary formed by the stream, a topographical feature of some antiquity. Structural evidence appears limited to the southern slope.

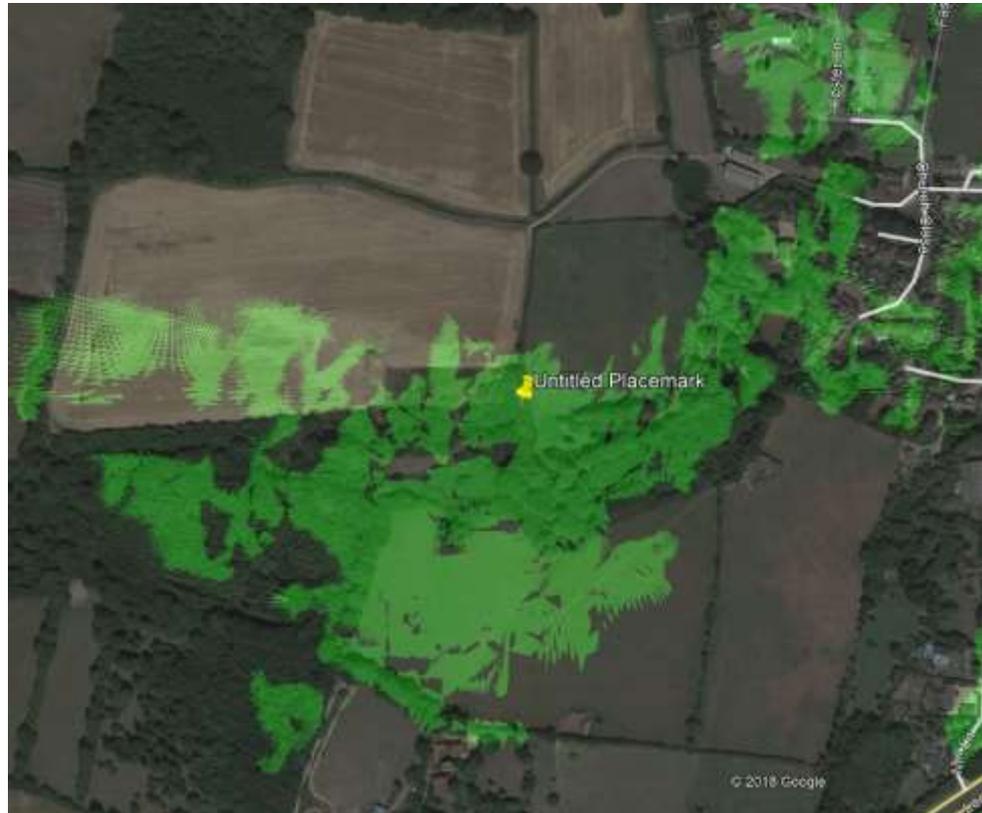
⁶ Derived from the viewshed tool within Google Earth, based on a viewer located at the approximate location of the stone building surveyed in 1999 (yellow pin), with a viewing height of 2m above ground level. The theoretically visible ground is coloured green.

the downland in the distance. Views between the house and the bath-house will also have been important, as was the main approach along the ridge from the west. The land to the north formed part of the rural landscape associated with the villa, but was of lesser significance given the lack of significant intervisibility from most of the villa complex as currently understood (see viewshed below⁶).

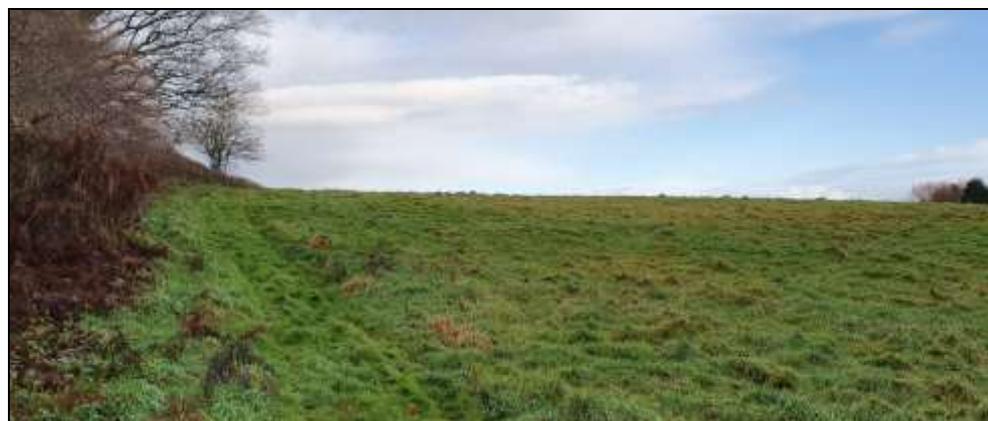
View N from the SE corner of the SM (location of the possible stone building surveyed in 1999) – the N edge of the SM broadly corresponds to the large tree in the left margin

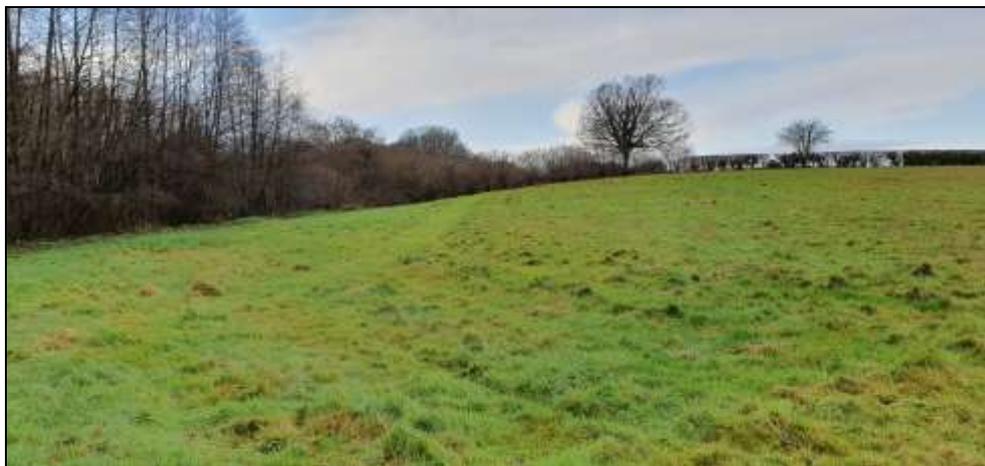
View W from the bath-house towards the SM, showing the slope of the ridge – the N edge of the SM lies level with the large central tree, extending down to the left, The stone structure located in 1999 lies at the point where the treeline extending from the left meets the hedgerow
